NSSA Framework for Assessment Venues

First survey on optional locations
 for the 2nd and 3rd round of the pilot project

German Technical Cooperation with Myanmar
NSSA Framework for Assessment Venues |
First survey on locations | Conclusions for 2nd and 3rd round of the pilot project
Draft Report

place and date: Hamburg | Yangon | 10 July 2015

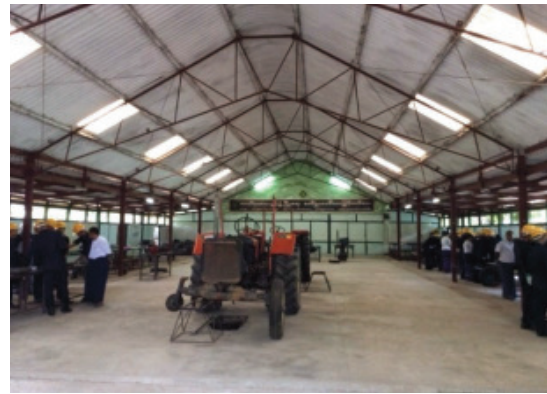
Machine workshop for assessments

The lattice workshop building for the intended assessments has a usable area of 38 m x 18 m = 684m² without partitions, room heights of appr. 7 / 3.50m and a gabled (basilica) roof with metal sheet cover. The temperatures, especially in the lower parts, are rather high as the ventilation is not sufficient. The natural lighting is limited, but generally acceptable. The overall building status can be summarized as "old but in tolerable conditions". Presently, the building serves for auto mechanics training.

- Ventilation openings of upper gable walls (replacement of metal sheets by metal grids)

- In any case, mechanical fans should be mounted to support natural ventilation in the roof area
- Refurbishments including interior wall paint, paint of constructive elements like pillars and girders, paint of external false ceilings, repair of window grids would improve the general impression of the building.

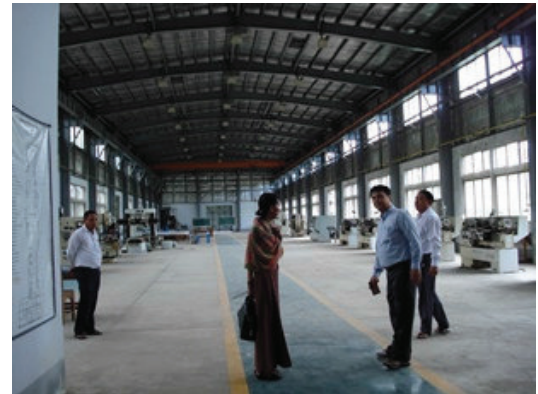
Existing workshop interior condition

foundry workshop needing more ventilation). Some minor equipment/furniture (office, auxiliary rooms) appeared outdated, but is easily improvable.

- Renewal of wall painting, particularly in public access areas
- Additional lighting for the work areas, particularly in foundry workshop
- Probably mechanical ventilation for the working areas, particularly in the foundry workshop
- Additional electrical installations for the individual working booths
- Creation of a movable reception/wardrobe zone, a zone for theoretical instructions and an assembly zone for waiting phases for each occupational area, designed in an NSSA CI.

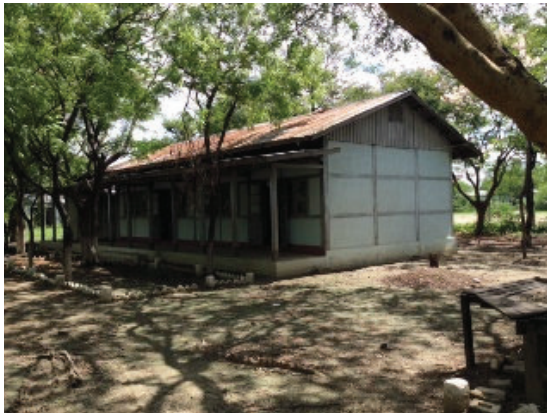
Current training building condition

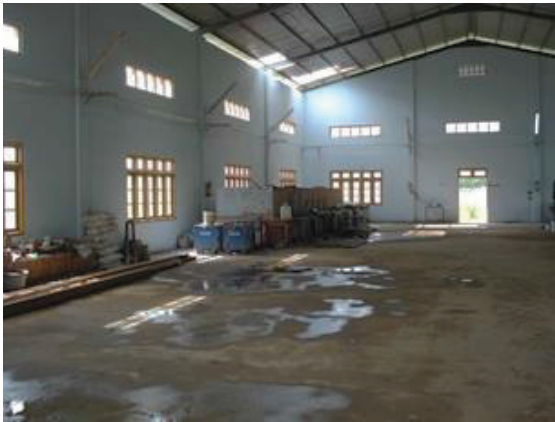
Workshop with roof damages

The centre has got a director, but is not used. One of the reasons, according to the director, is the missing accessibility by public transport. The building shows an advanced stage of dilapidation. Parts of the roof are missing, windows are broken, the whole site is flooded. The interior is damaged by weather and a severe lack of maintenance. If the building should be used, a concept for drainage of the whole compound, a range of restoration works and additional building measures for adjacent rooms, sanitary facilities etc. would be necessary. Although the management was open to participate in the project, besides the lack of infrastructure no personnel would be available.

However, the condition of the compound and building could be refurbished with noteworthy efforts for future assessment and training purposes.

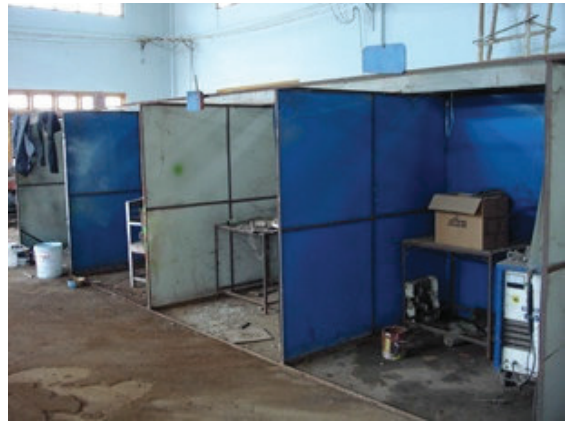
Former welding booths

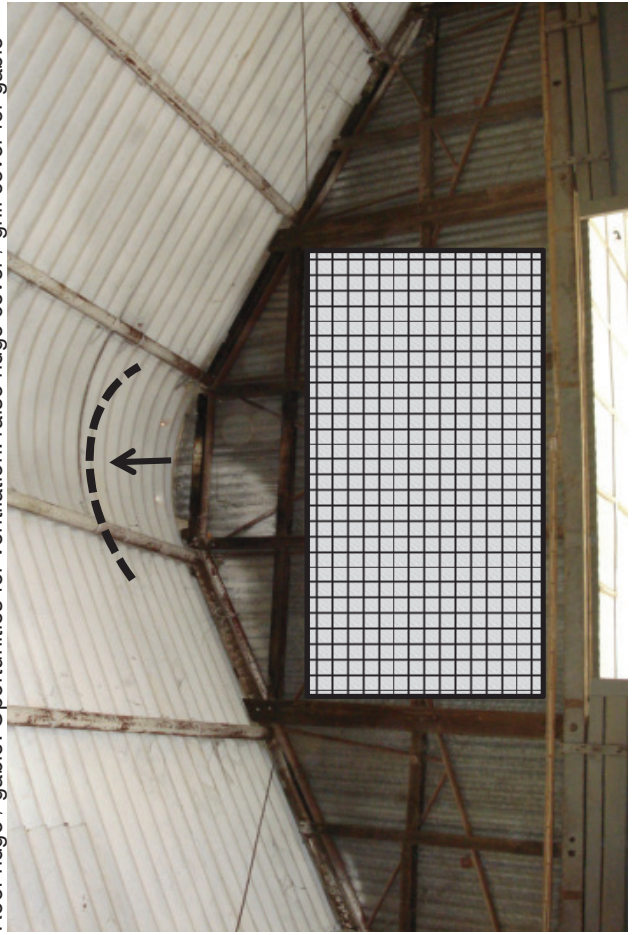
Typical workshop building
Roof ridge / gable: Opportunities for ventilation: raise ridge cover / grill cover for gable

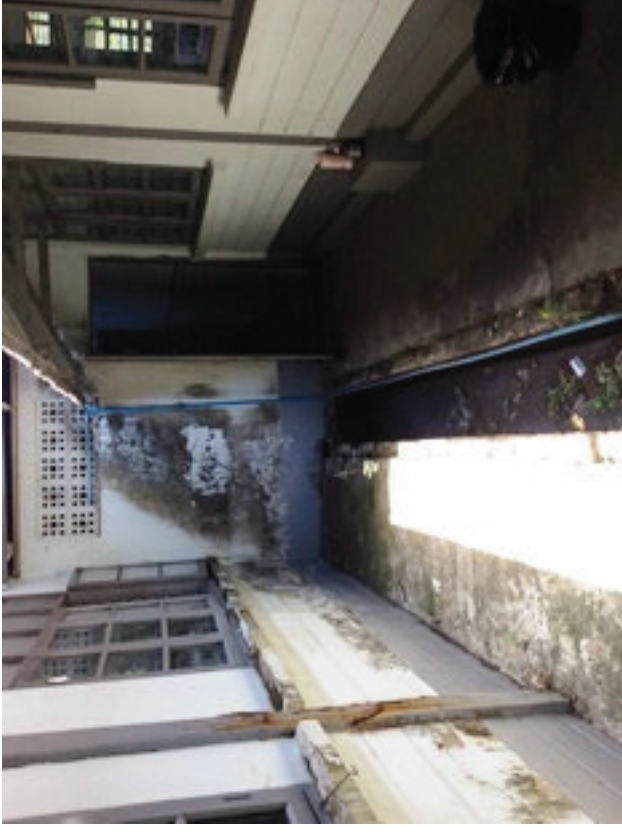
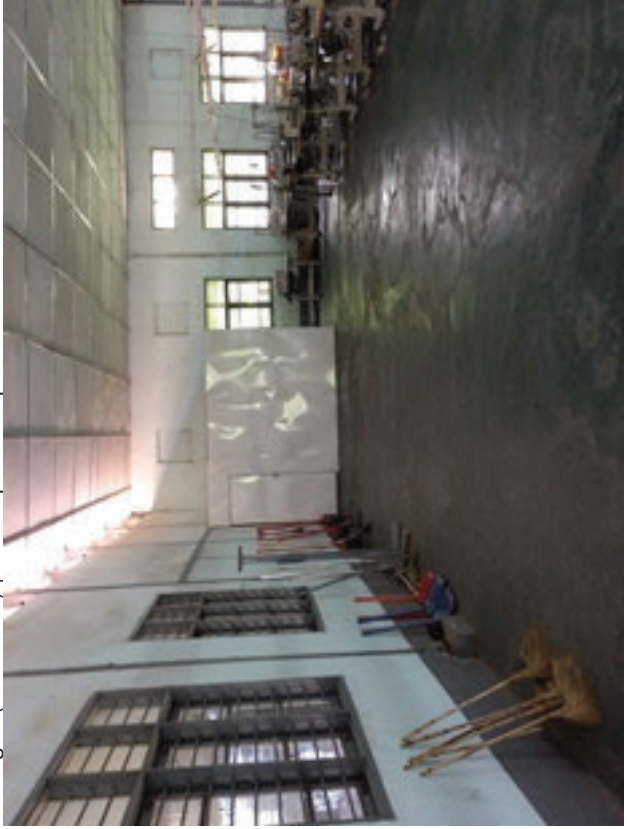
Leakages (roof / floor) | Room part with provisional store room

- Repair the roof and the false ceiling as well as further (light water damages)
- Improve ventilation be mechanical fans

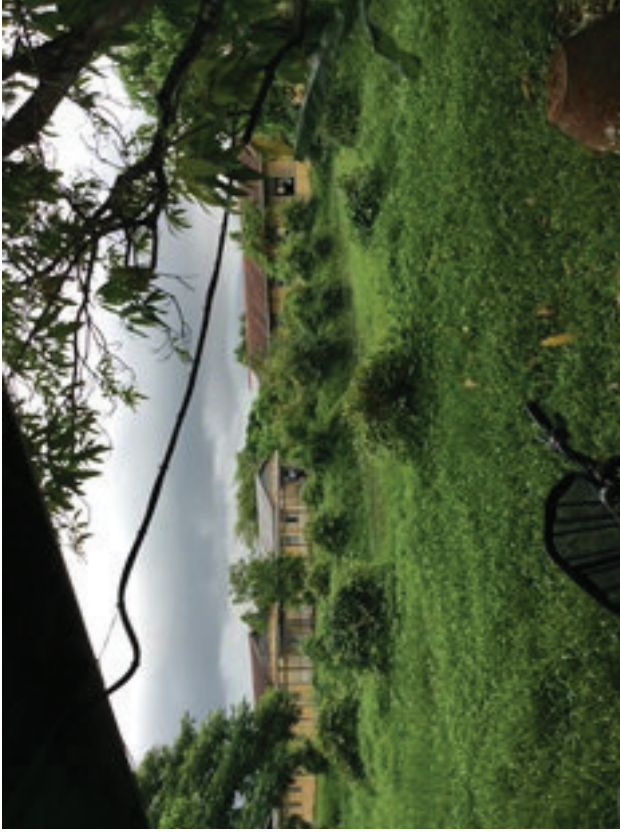
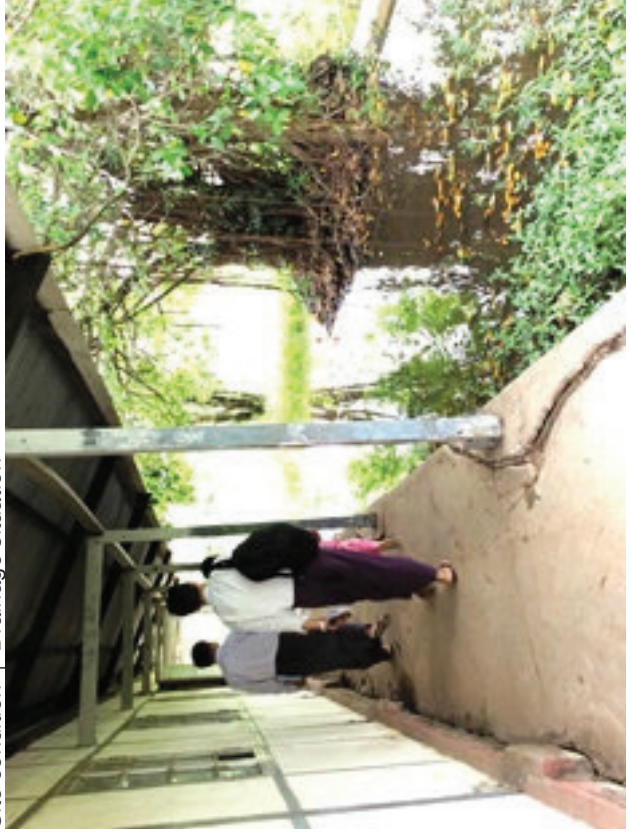
The whole compound is affected by flooding during rainy season. Already at the beginning of the rains, all grounds are swampy and full of insect breeding. Snakes are said to be common on the compound. The walkways and their roof constructions are in very bad shape. A lot of concrete floors in the buildings and outside show biggest cracks and warpings.

Site condition | Drainage situation

- restore the paint and varnish of buildings / building parts that shall be further used
- repair the respective roofs
- refurbish the power supply
- care for adequate water supply and disposal as well as for sanitary facilities
- restore the floors in the buildings
- restore the walkways outside

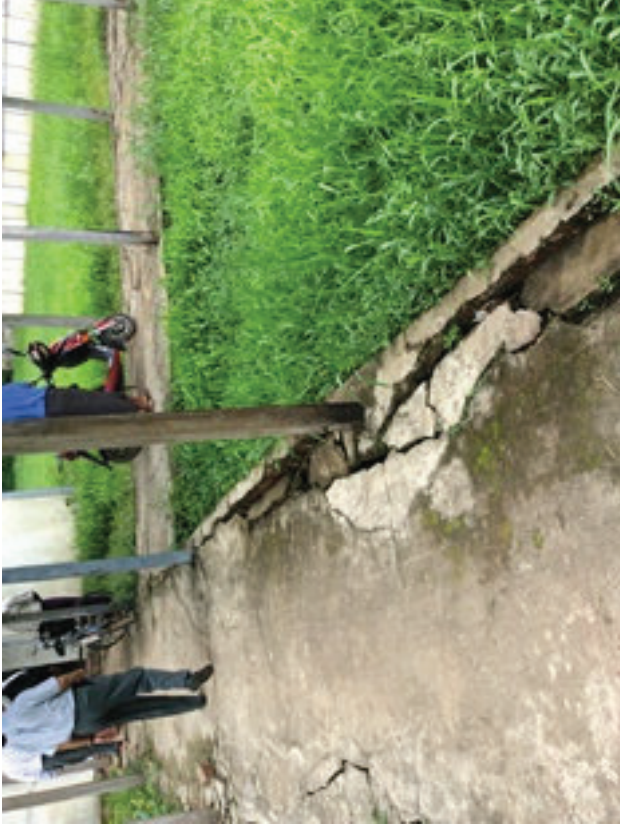
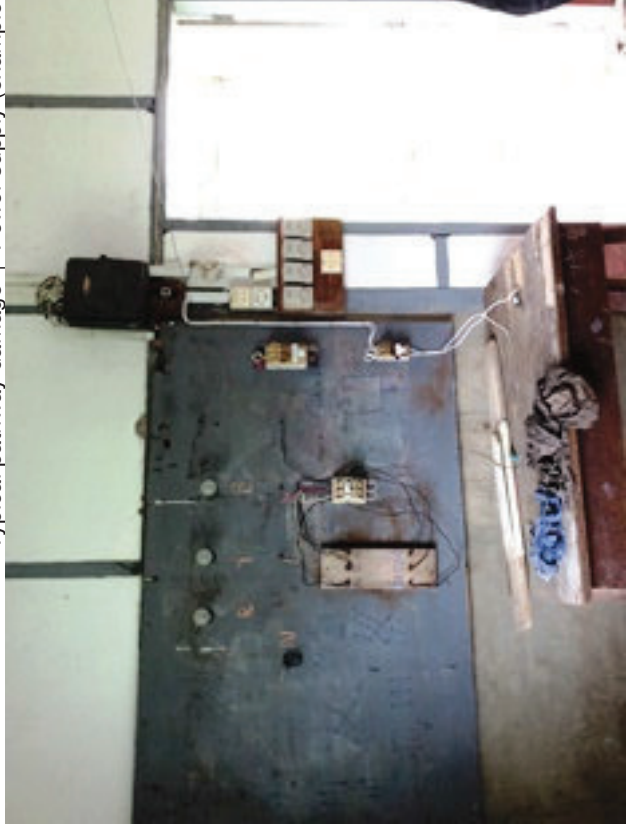
Typical pathway damage | Power supply (example)

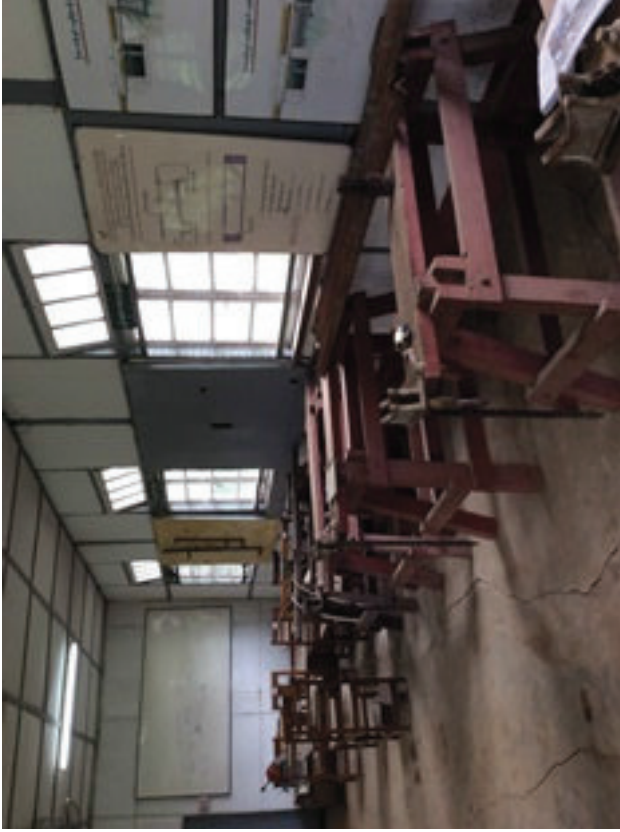
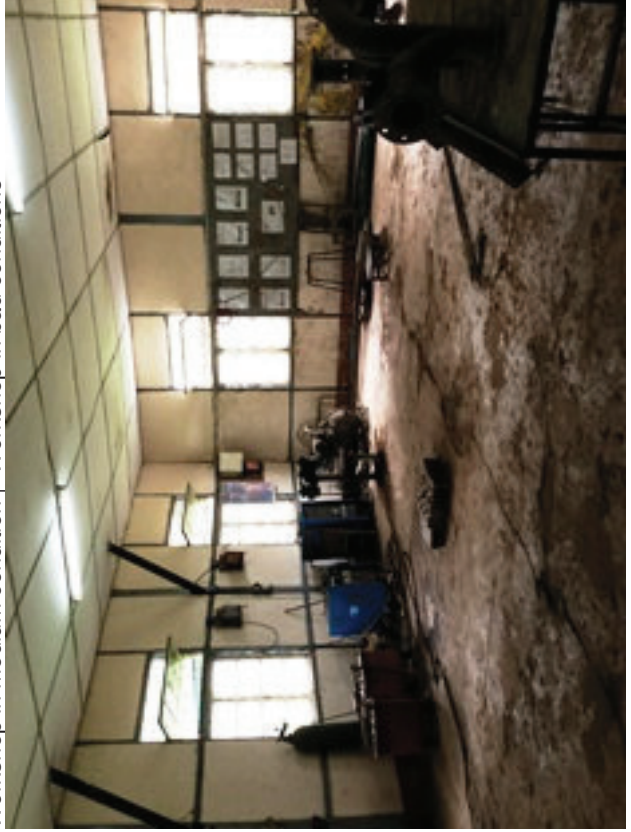
Workshop in medium condition | Workshop in bad conditions

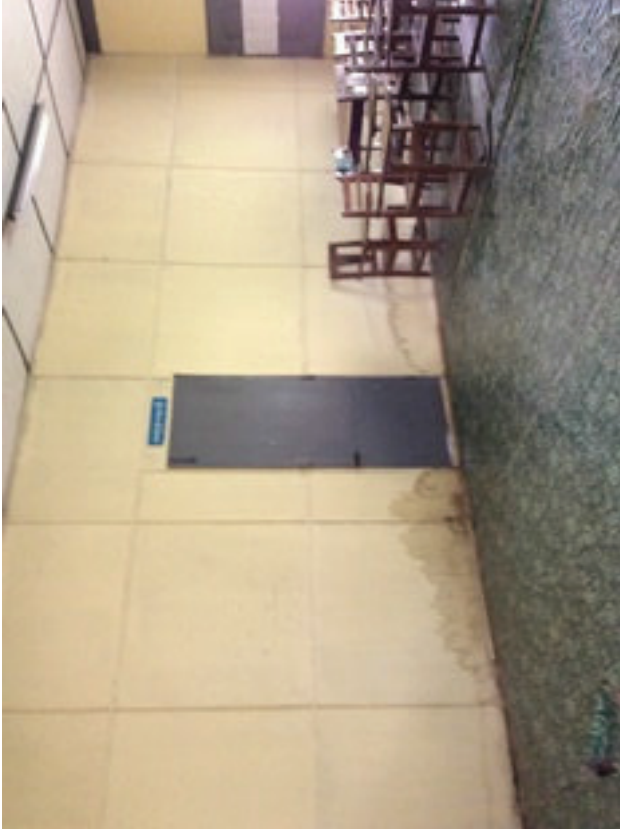
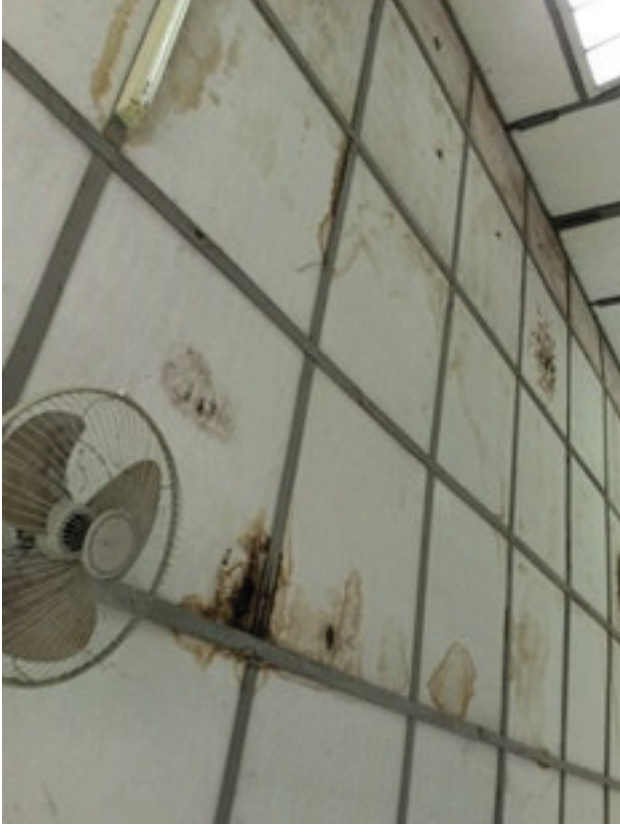
Hence, also the buildings are damaged by water from the ground and through faulty roofs in different stages. All buildings suffer from a lack of maintenance and construction mistakes like open gaps between walls and ceiling etc. Water damages have influenced the constructions from “normal” defects as broken or moldy false ceilings, destroyed wall painting and slight cracks of the floors up to heavy deformations of the whole building. Some workshops are basically useable, but a lot seem not worthwhile to be restored, while the status of the access zones ranges from acceptable to dangerous.

Wall damage due to missing drainage | Typical floor damage

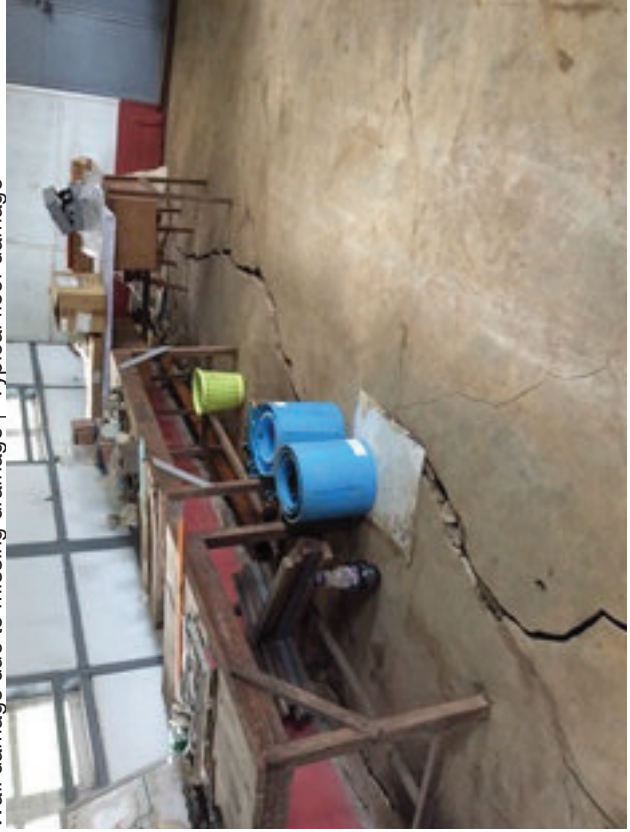
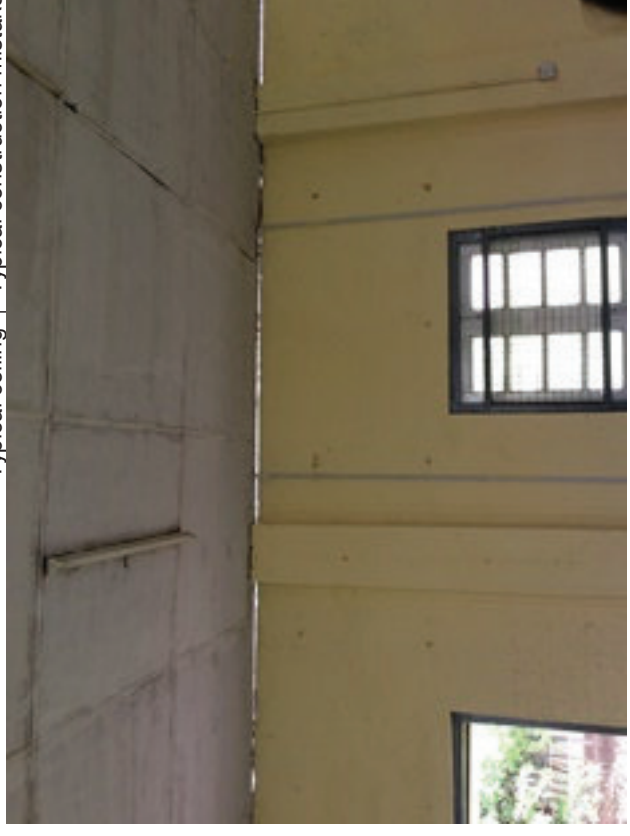
Typical ceiling | Typical construction mistake

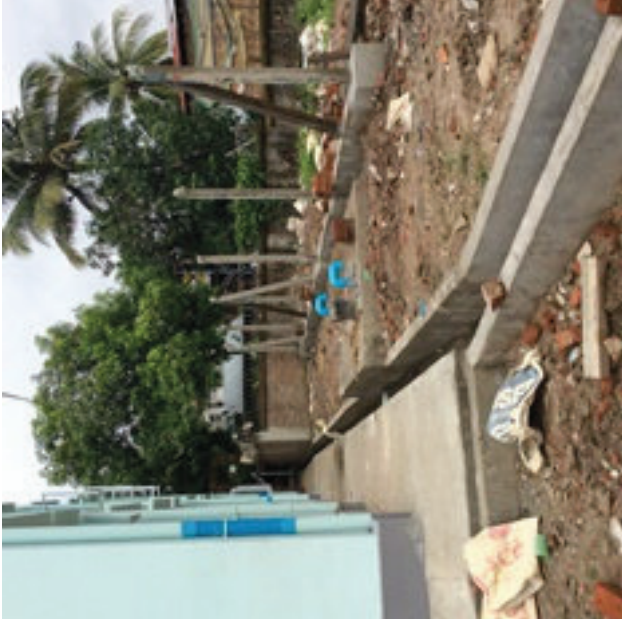
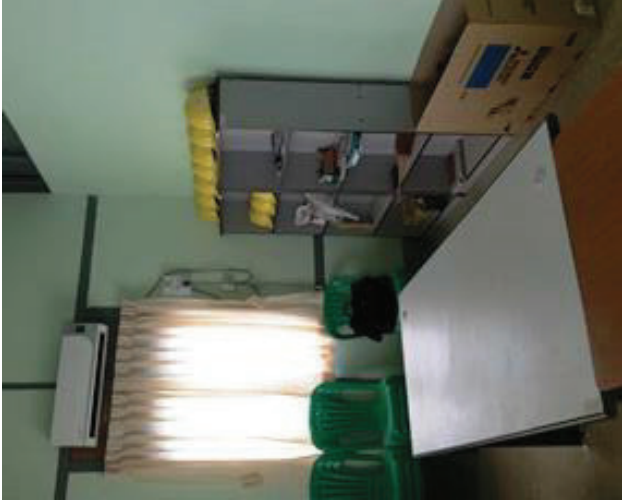
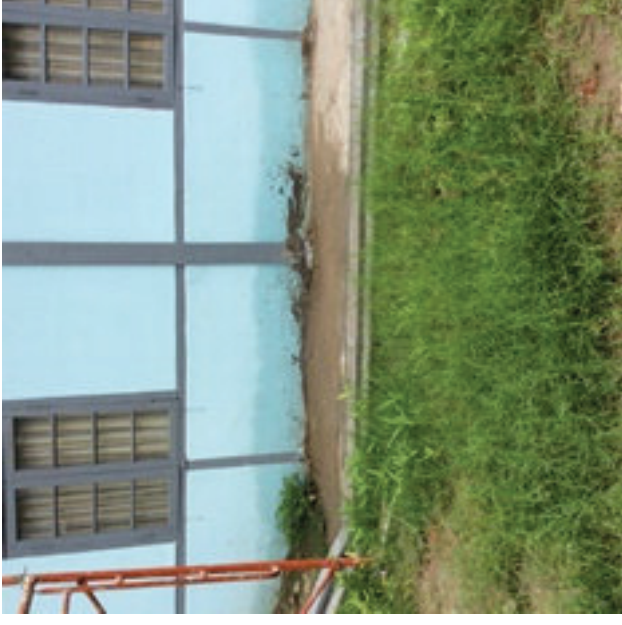
The building is located in a lower area of the compound. Consequently, the structural elements, especially the wooden parts, are partly damaged by flooding in the rainy season. Some renovation works at the building and the construction of a rainwater drainage are presently being carried out.

Upper row: Rainwater drainage | Assessors' room | Rainwater damage facade
