NSSA Framework for Assessment Venues

First survey on optional locations
 for the 2nd and 3rd round of the pilot project

German Technical Cooperation with Myanmar
NSSA Framework for Assessment Venues |
First survey on locations | Conclusions for 2nd and 3rd round of the pilot project
Draft Report

place and date: Hamburg | Yangon | 10 July 2015

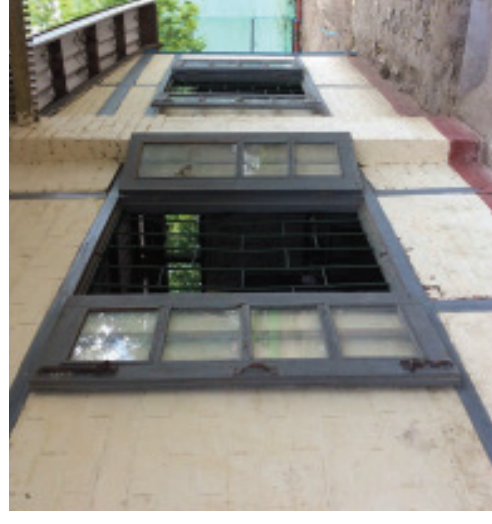
Building construction status: interior | Facade
