NSSA Framework for Assessment Venues

First survey on optional locations
 for the 2nd and 3rd round of the pilot project

German Technical Cooperation with Myanmar
NSSA Framework for Assessment Venues |
First survey on locations | Conclusions for 2nd and 3rd round of the pilot project
Draft Report

place and date: Hamburg | Yangon | 10 July 2015

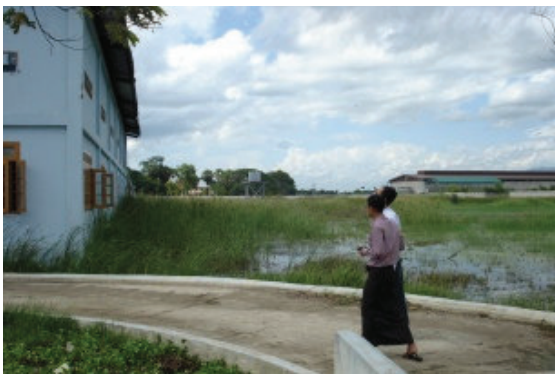
Flooded compound

The centre has got a director, but is not used. One of the reasons, according to the director, is the missing accessibility by public transport. The building shows an advanced stage of dilapidation. Parts of the roof are missing, windows are broken, the whole site is flooded. The interior is damaged by weather and a severe lack of maintenance. If the building should be used, a concept for drainage of the whole compound, a range of restoration works and additional building measures for adjacent rooms, sanitary facilities etc. would be necessary. Although the management was open to participate in the project, besides the lack of infrastructure no personnel would be available.

However, the condition of the compound and building could be refurbished with noteworthy efforts for future assessment and training purposes.

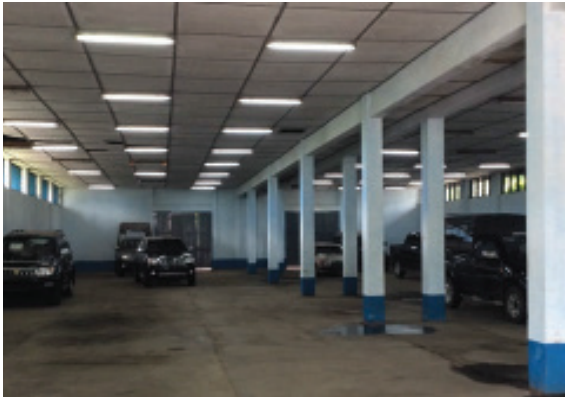
Garage to become assessment venue

The premise is constructed as combination of 2 rectangular concrete skeleton structures, each with a gable roof. The combination forms one bigger hall with a central double row of pillars covered by central roof guttering along the contact line of the 2 eaves. This guttering is damaged and causes leakages. The false ceiling made of chipboard is heavily damaged hereby.

According to the impressions during the first visit it seems recommendable to:

- Repair the roof
- Refurbish (light) water damages at walls and floor as far as necessary
- Replace the damaged parts (at least) of the false ceiling
- Implement new electrical installations incl. high voltage
- (Probably) install water supply and discharge for workshop purposes (to be re-checked)

- Paint the interior and external walls
- Repair damaged windows as far as necessary
- Add mechanical fans to improve ventilation
- For heavy equipment like car lifters the opening of the floor and construction of additional load bearing foundations will be necessary.
- Overhead cable trays and cable channels will be necessary
- Implement/construct store rooms for tools and material as well as a room for assessors

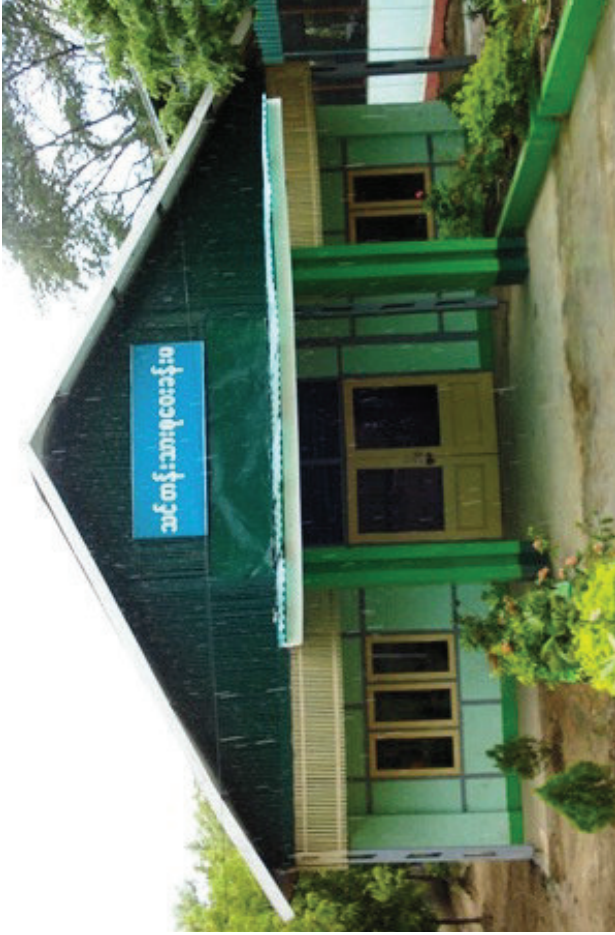
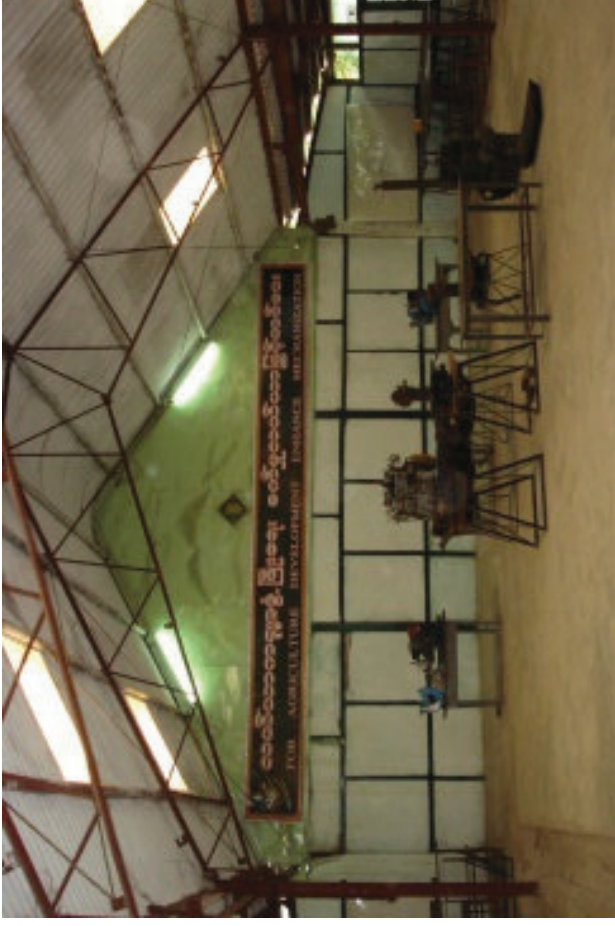
2.1 Agricultural Mechanization Training Centre, Meik Hti La

Workshop for Assessments
Typical work place

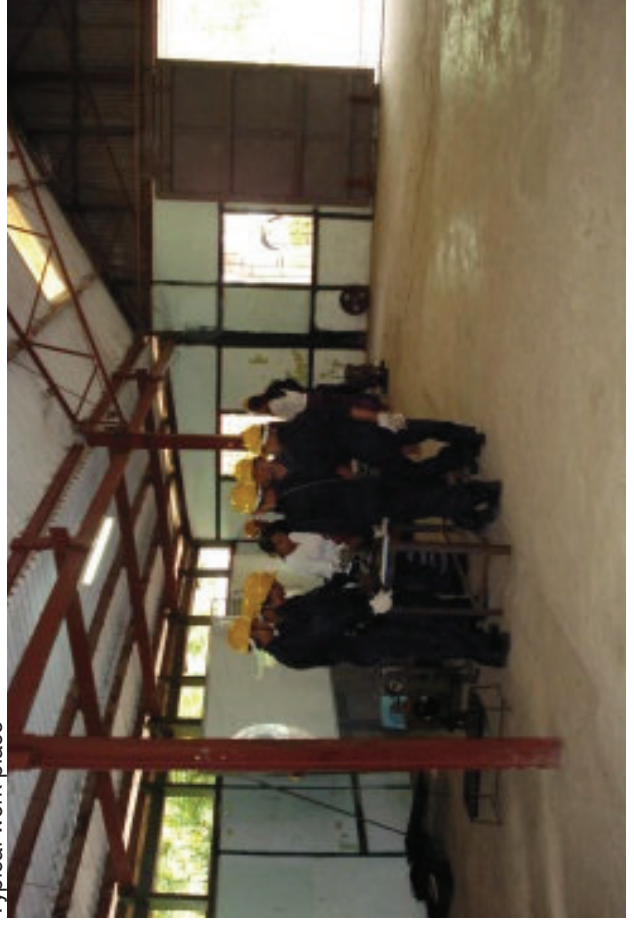
Typical workshop building
Roof ridge / gable: Opportunities for ventilation: raise ridge cover / grill cover for gable

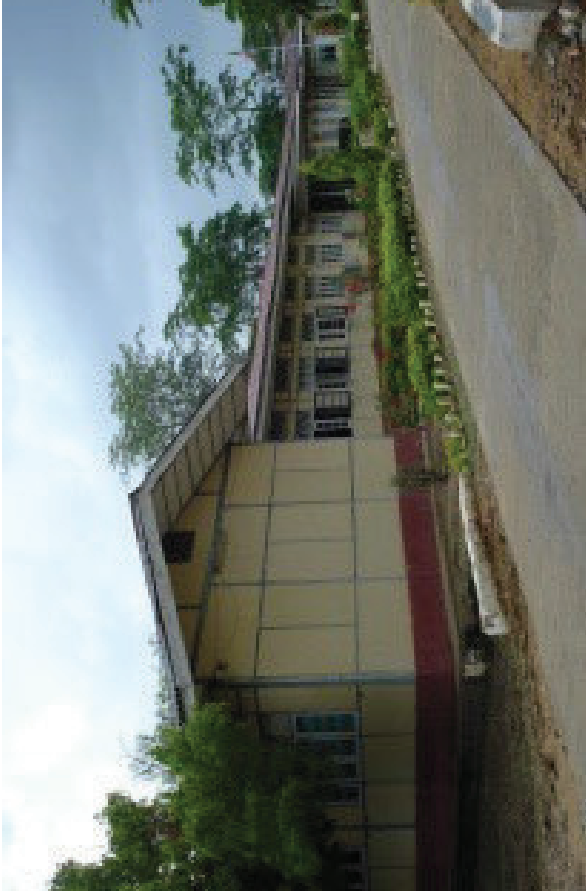
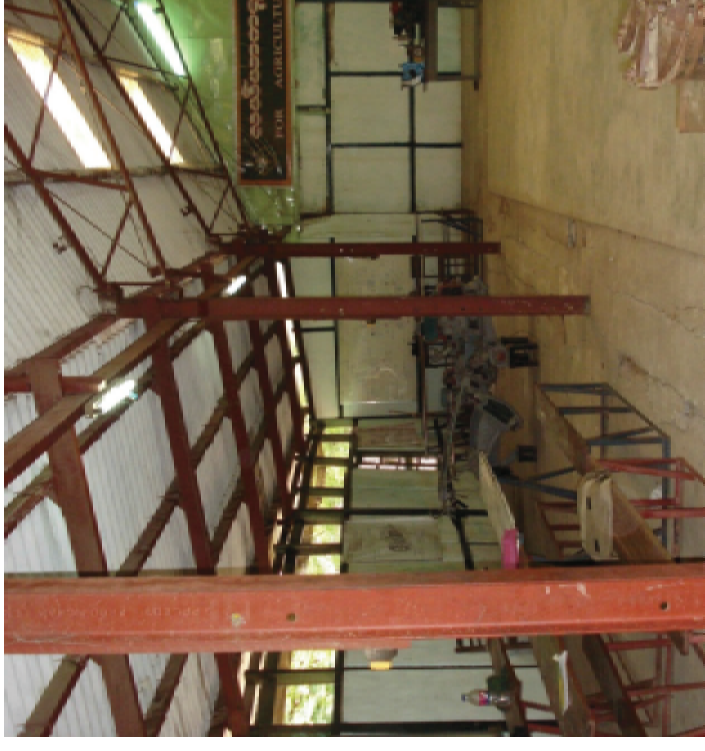
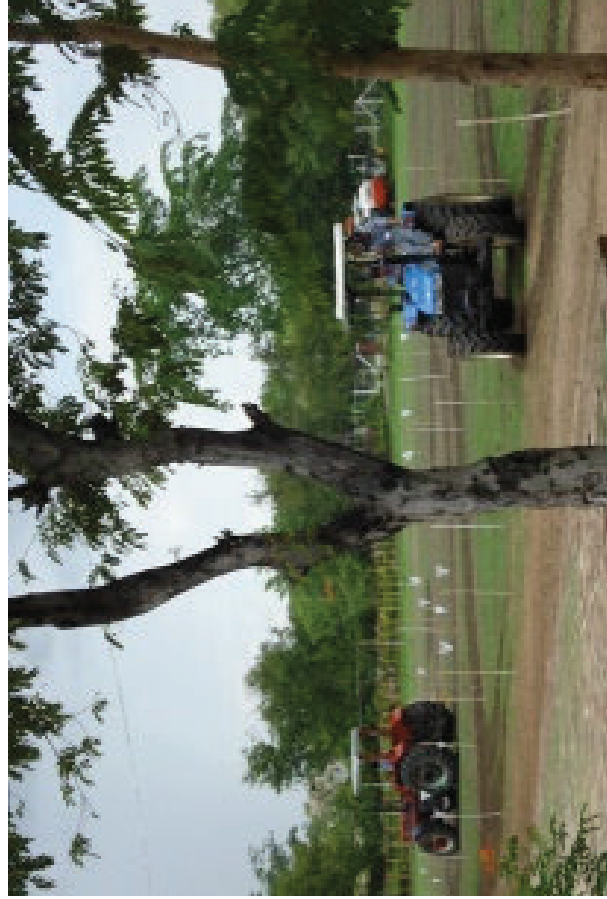
2.1 Agricultural Mechanization Training Centre, Meik Hti La

Main building | Open air area (here: tractor training)

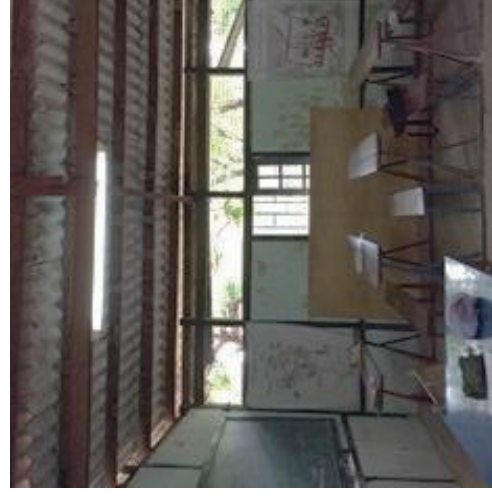
Building construction status: interior | Facade

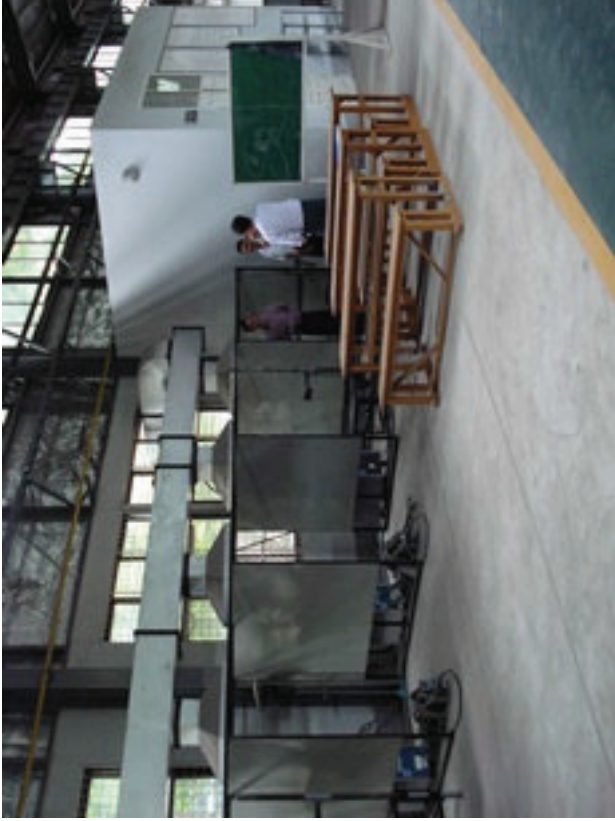
2.2 Industrial Training Centre ITC No. 2, Mdy

Welding workshop | Wall paint access zone

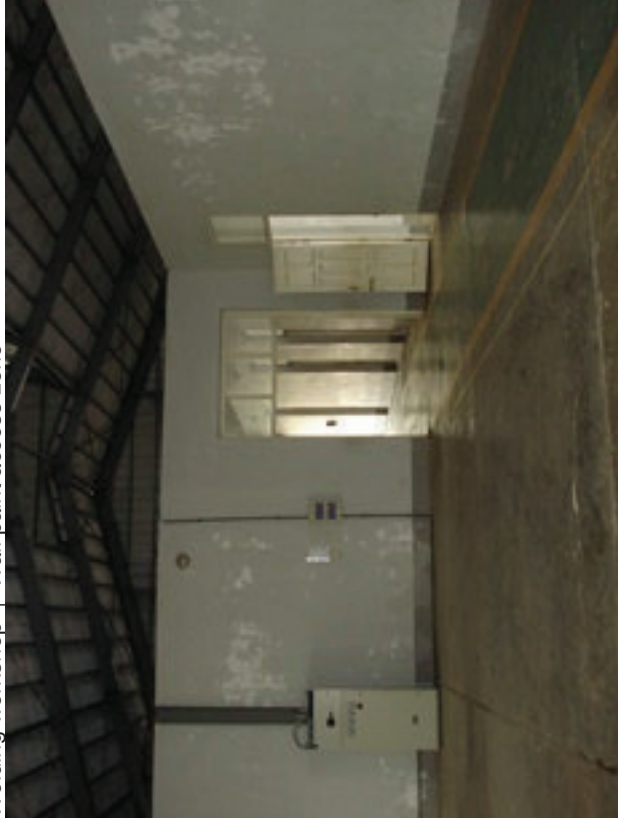
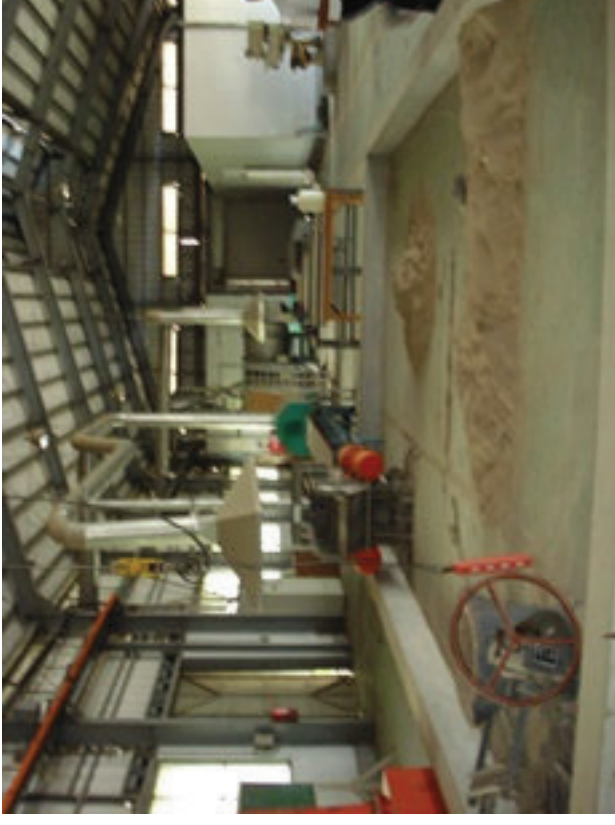
Foundry workshop

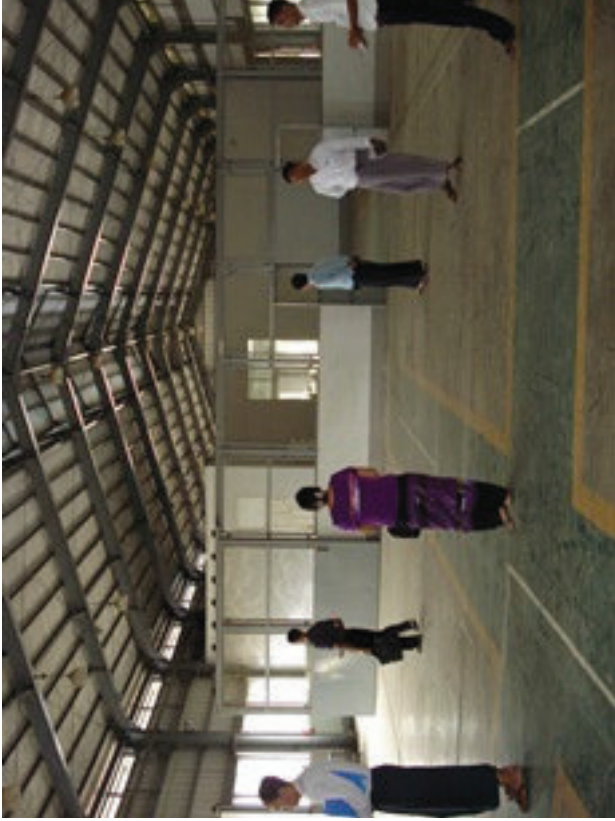
2.2 Industrial Training Centre ITC No. 2, Mdy

Empty workshop | Machine workshop

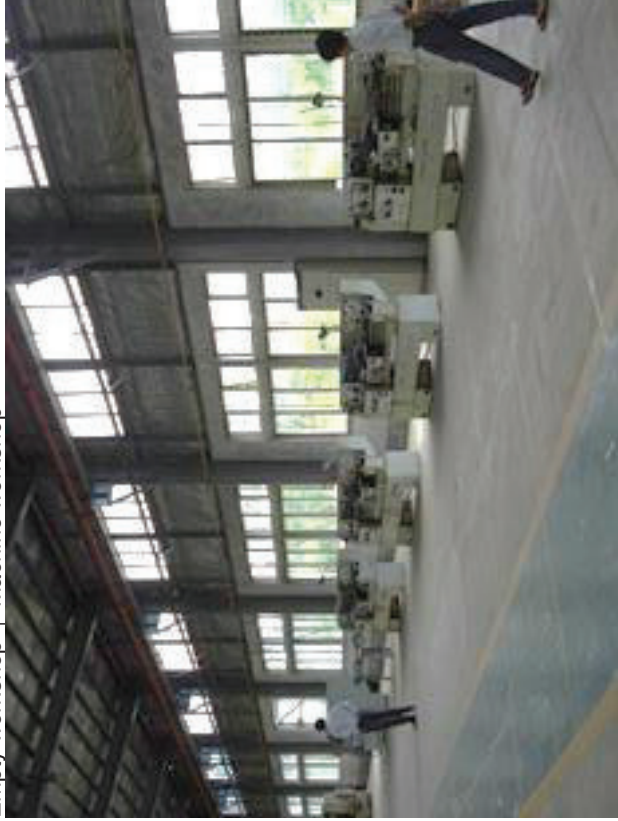
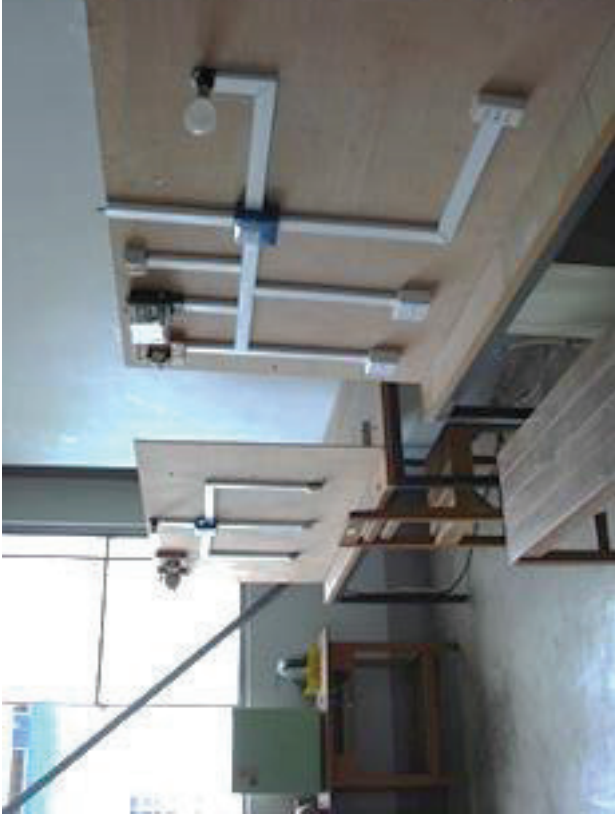
Electrical testing installations | Access zone

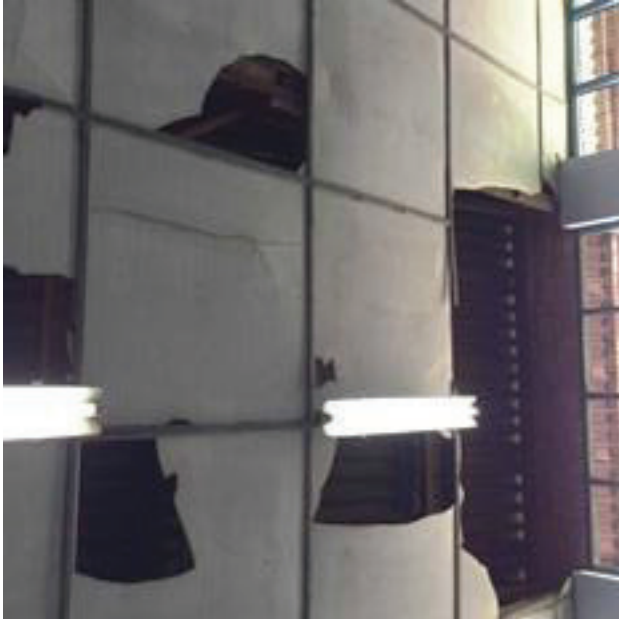
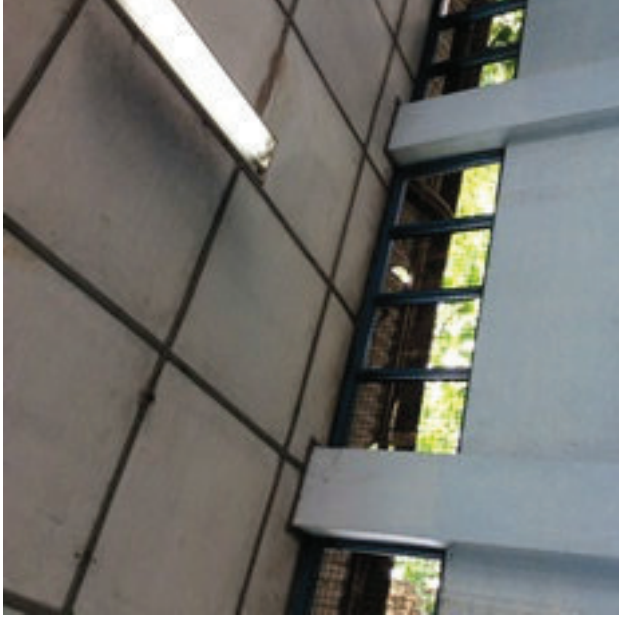
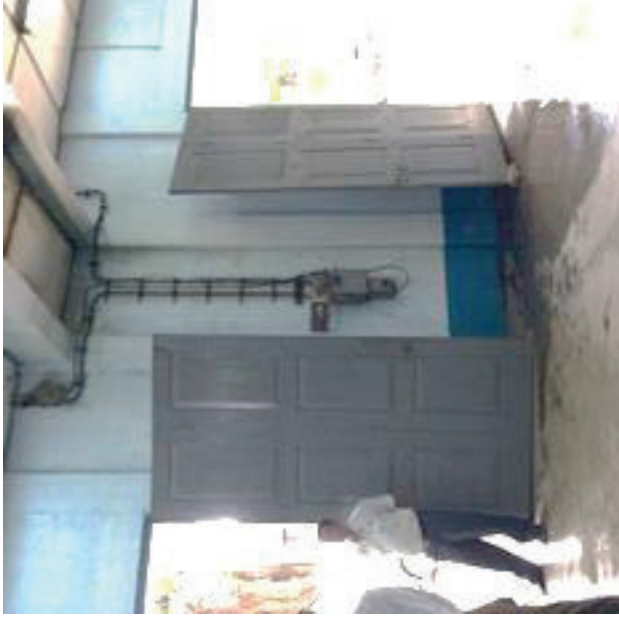
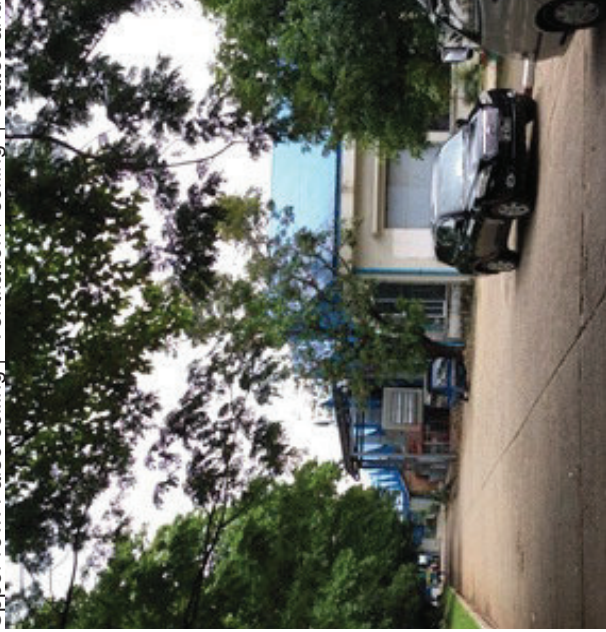
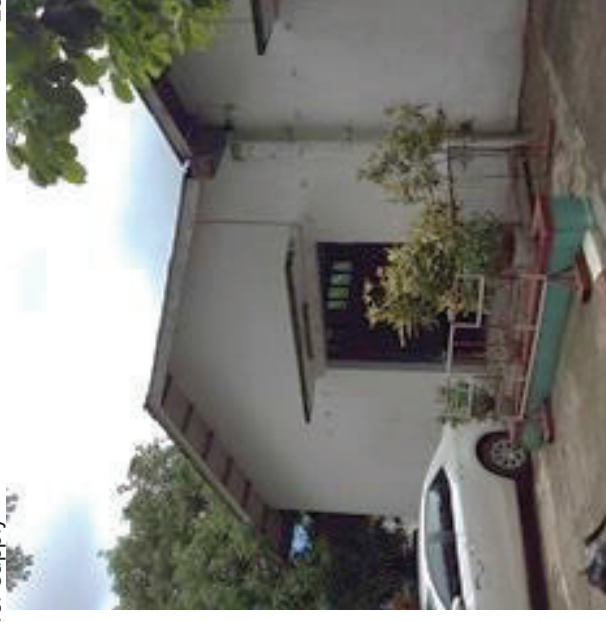
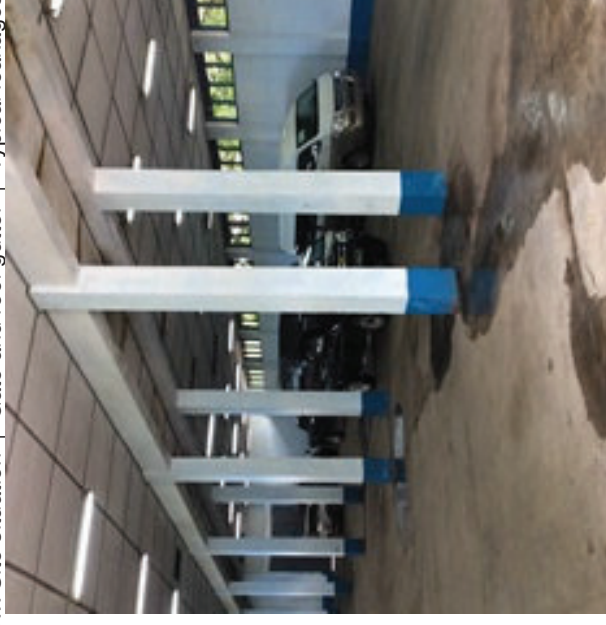
2.6 Mol No. 11 Heavy Industry Work Place, Ygn

Upper row: False ceiling | Ventilation / ceiling | Gates and power supply

Lower row: Site situation | Gate and roof gutter | Typical leakages

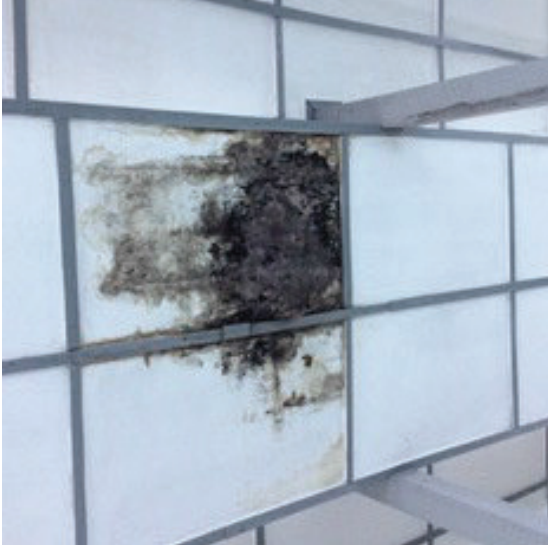
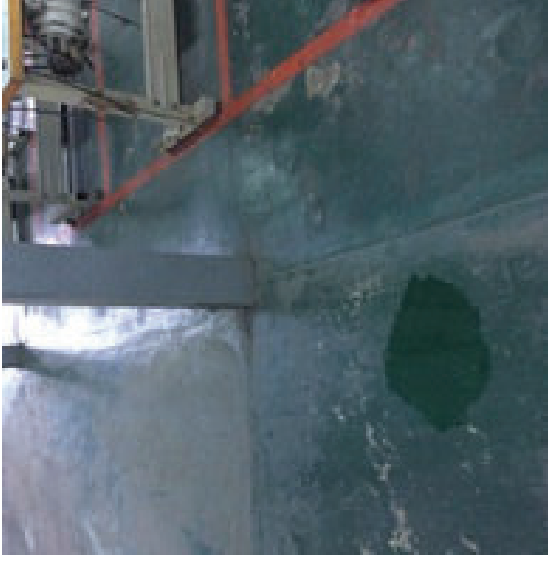
2.8 Garment Manufacturing Association Training Centre, Ygn

Leakages (roof / floor) | Room part with provisional store room

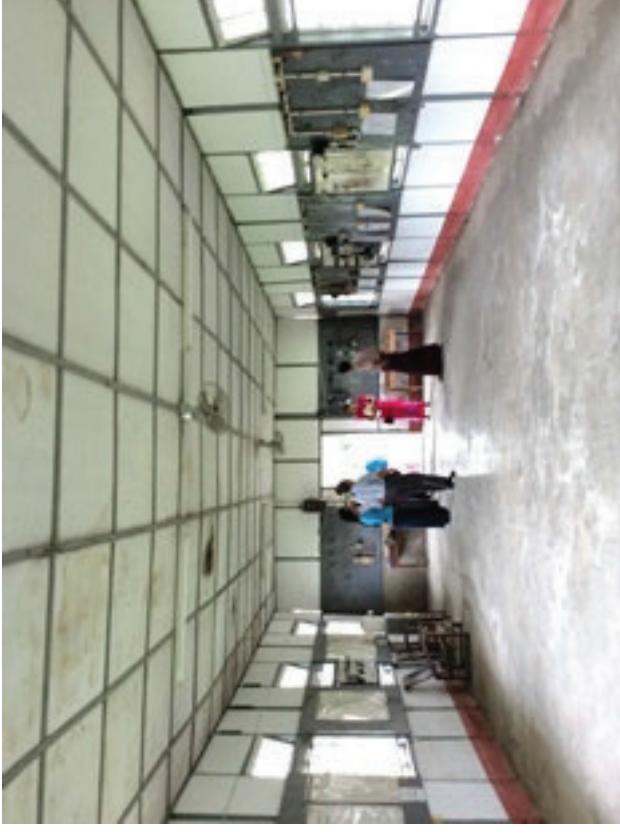
Workshops in relatively good condition

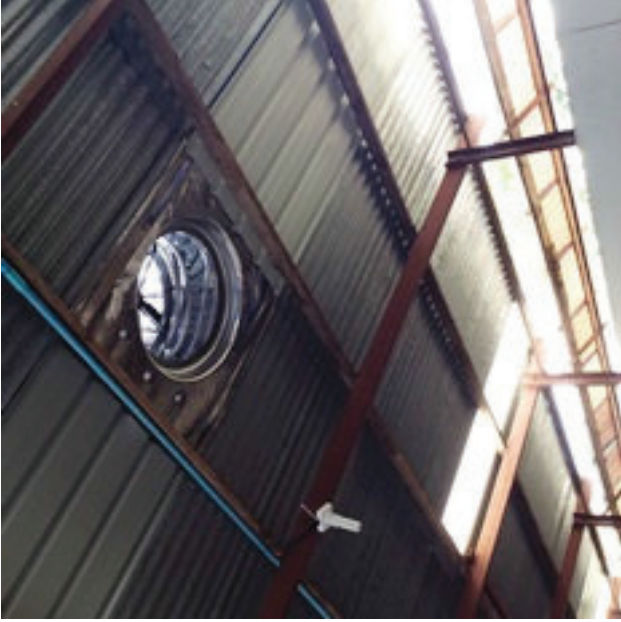
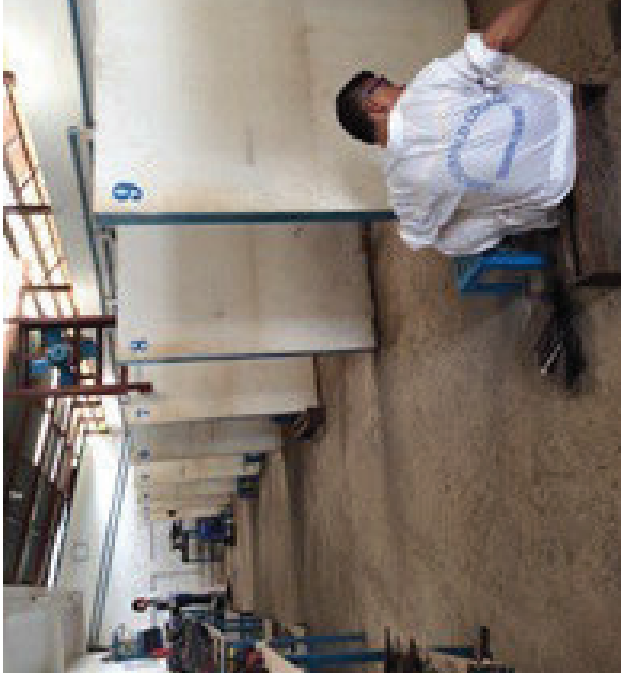
2.12 Arbourfield Welding Centre

Upper row: Roof ventilation welding places | interior welding places | site entrance

Lower row: External welding places | Assembly zone
